# Manhole Inspection Summary

Manhole # S35A\_\_003MH

**Location** Address: **601 hunter st**

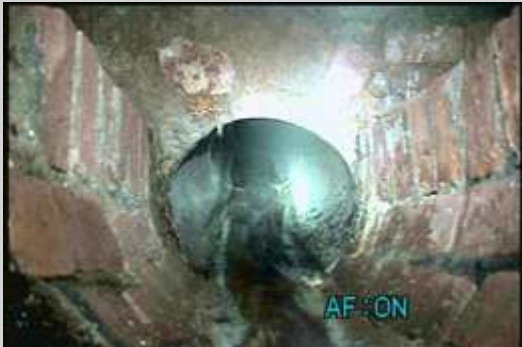
12 O'Clock Outflow

10 in. Circular Gravity Sewer  
Pipe Out @ 12 O'Clock

Pipe Material: **Clay** ☐ Pipe Lined

Invert Depth: **10.75** (ft.) Flow Characteristics: **Fast**

Infiltration: **None** Pipe Seal Cond: **Unknown**

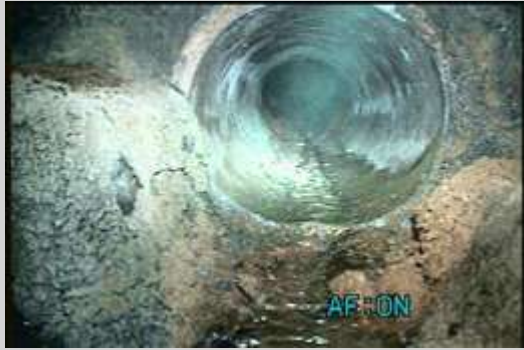
8 O'Clock Inflow

10 in. Circular Gravity Sewer  
Pipe In @ 8 O'Clock

Pipe Material: **Clay** ☐ Pipe Lined

Infiltration: **None**
